## TNR153856 - Norfolk Southern Intermodal Facility Photos

Permit No.:	Site Location:	Permittee:	Date:	Time On-Site
TNR153856	3000 Norfolk Southern Way, Rossville, Fayette Co., TN	Norfolk Southern Railway	Aug. 18, 2015	01:30 PM

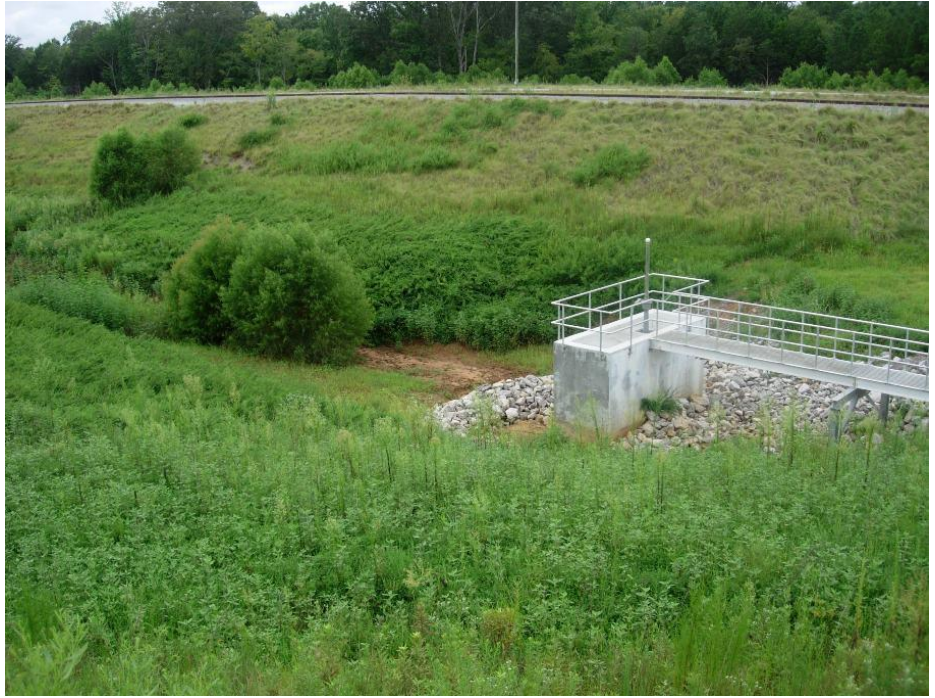
1	Cliff Caudle	
<b>Description</b> <p>View southwest across Permanent Basin 4. Lower slopes previously observed to be unstable and gullied had been re-graded and re-seeded, but lacked full growth in a few places around the outfall structure. A stone filter ring had been placed immediately up-gradient from the intake to the slotted box culvert to provide velocity dissipation and promote settlement of potential suspended sediment.</p> <p><i>(Compare photo 1 – May 6, 2016 inspection)</i></p>

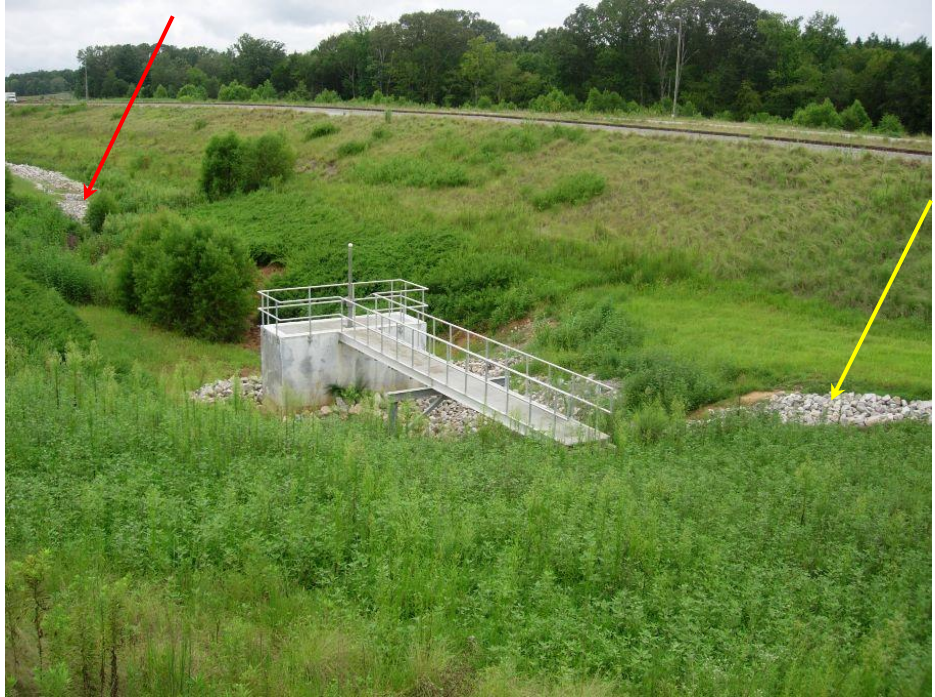
2	Cliff Caudle	
<b>Description</b> <p>Additional view southwest across Permanent Basin 4. The bench above and north of the outfall structure had been re-graded and revegetated, and the flow path from the bench to the outfall had been riprapped for stability (yellow arrow). Note the northern end of the rip-rap shown in photo 3 below (red arrow).</p> <p><i>(Compare photo 1 – May 6, 2016 inspection)</i></p>

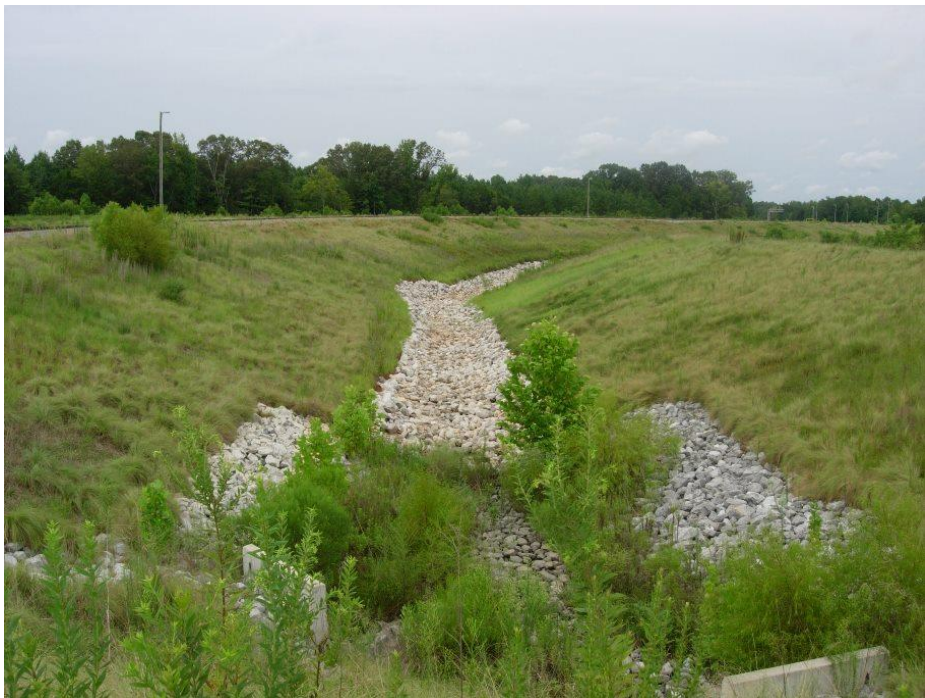
3	Cliff Caudle			
Description				
View north from the south end of Permanent Basin 4 showing stabilization of the low-flow channel with rip-rap and revegetation of slopes.  <i>(North end of low flow channel shown in Photo 1 – May 6, 2016 inspection)</i>				
Photo No.	Photographer

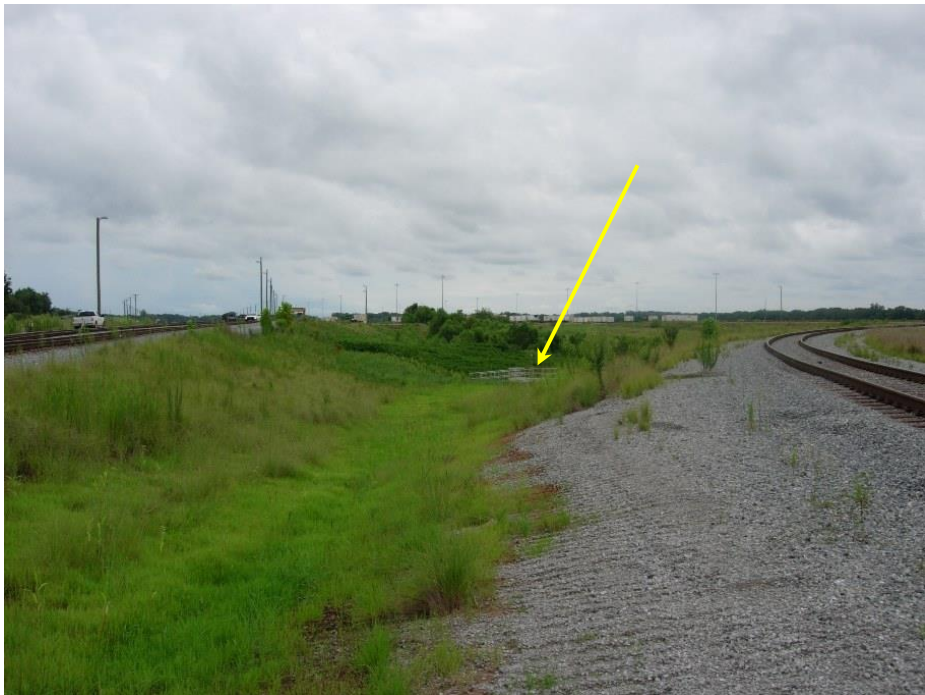
4	Cliff Caudle			
Description				
Additional view from the north end of Permanent Basin 4 - view south showing re-grading and effective revegetation of basin slopes up-gradient of the slotted outfall structure (arrow).

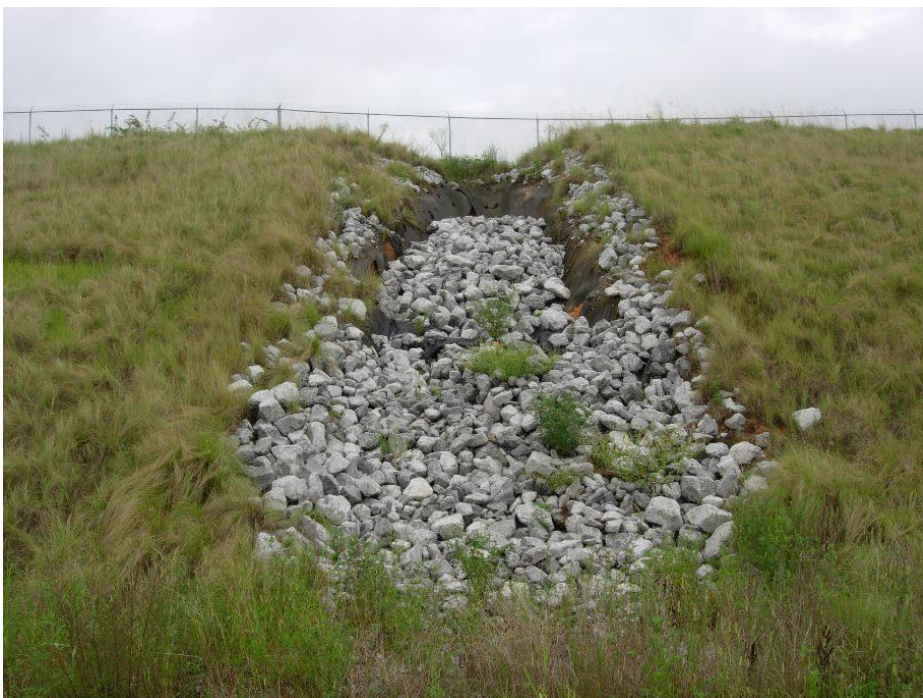
5	Cliff Caudle			
Description				
View east showing the rip-rap flume down the large eastern slope that had failed near light pole 115. No additional work had been performed here, but some natural revegetation had occurred since the May 6, 2016 inspection.  <i>(Compare photo 2 – May 6, 2016 inspection)</i>

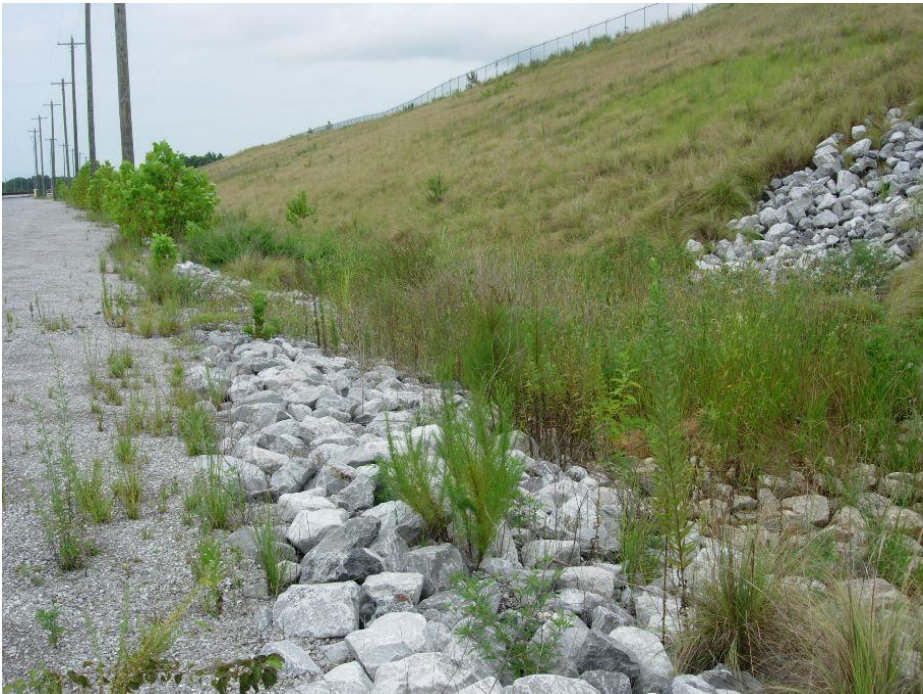
6	Cliff Caudle			
Description				
View northeast showing the area of sediment accumulation below the rip-rap flume shown in photo 2. Natural revegetation had progressed on the sediment at the toe of the slope.  <i>(Compare photo 3 – May 6, 2016 inspection)</i>

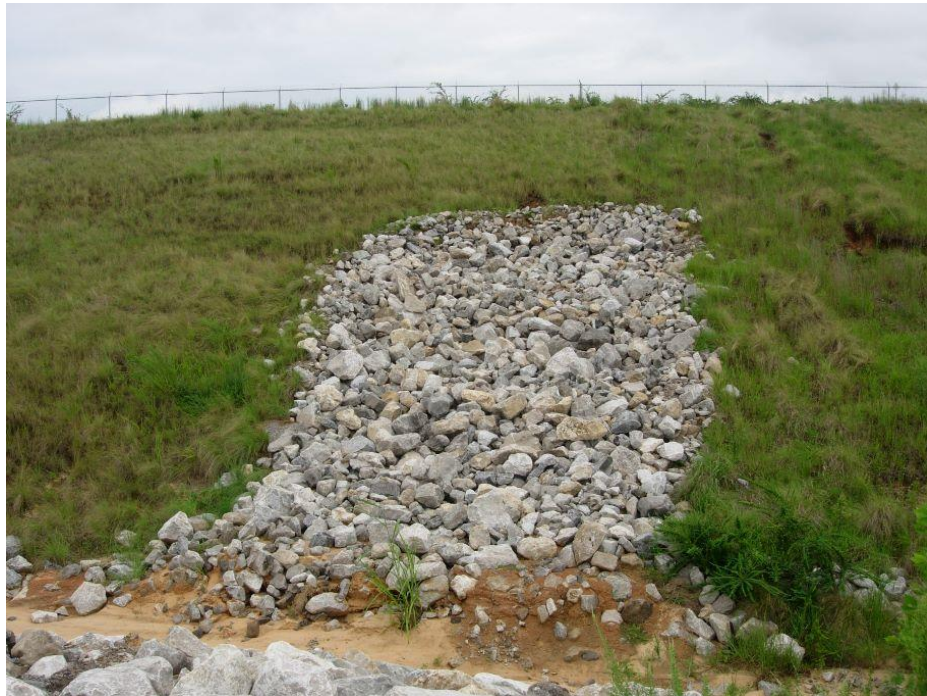
7	Cliff Caudle			
<b>Description</b> View east showing the slump slope failure that had occurred near light pole 125. The slump had been repaired with rip-rap and the sediment that had previously accumulated below the slump had been removed to restore channel flow at the toe of the slope. The restored flow line at the toe of the slope has a mostly sandy bottom.  <i>(Compare photo 4 – May 6, 2016 inspection)</i>				
Photo No.	Photographer

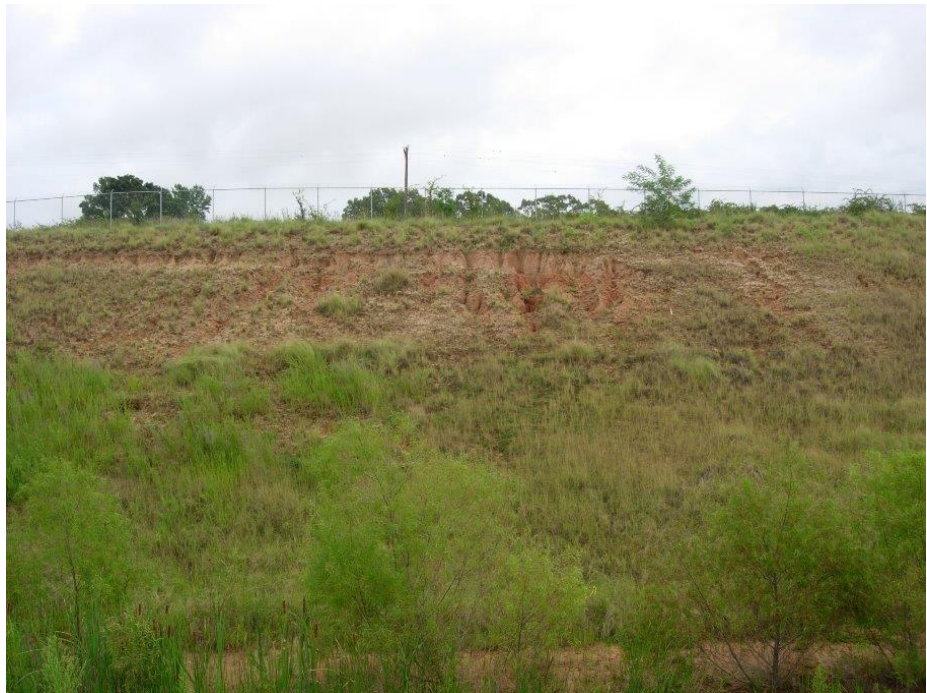
8	Cliff Caudle			
<b>Description</b> View eastward showing the large, sparsely vegetated area in the vicinity of light pole 129 above the eastern conveyance, noted in the May 6, 2016 inspection. Some revegetation of the lower slope had occurred, but the upper slope remained unstable.  <i>(Compare photo 6 – May 6, 2016 inspection)</i>

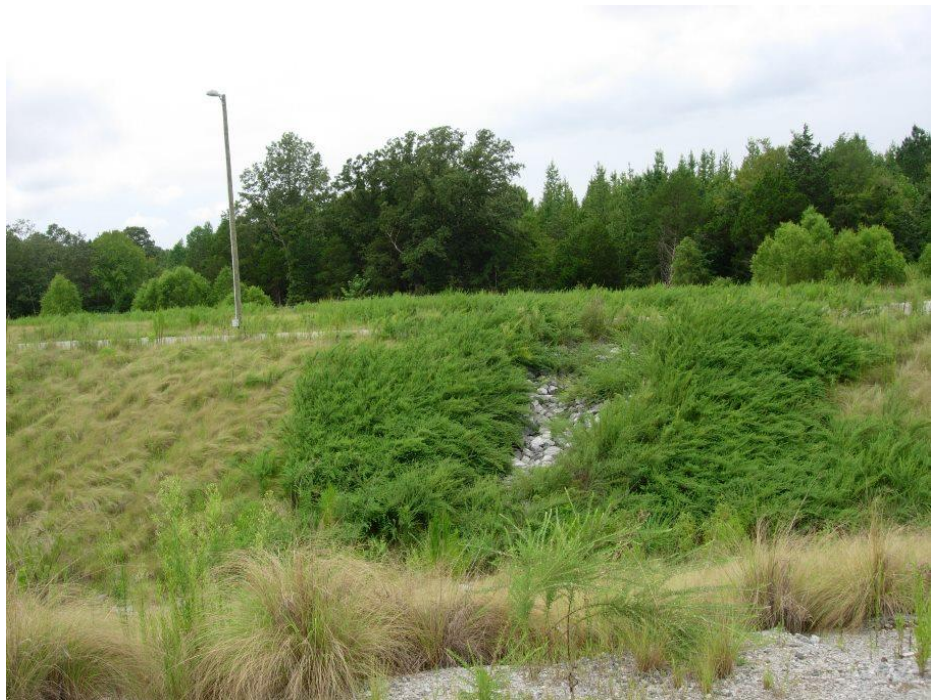
9	Cliff Caudle			
Description				
View west showing a formerly unstable, gullied portion of the west slope in the Pipe 12 drainage west of Permanent Basin 4. The area had been regraded, the gullied area had been stabilized with rip-rap, and the area overall was very well-vegetated.

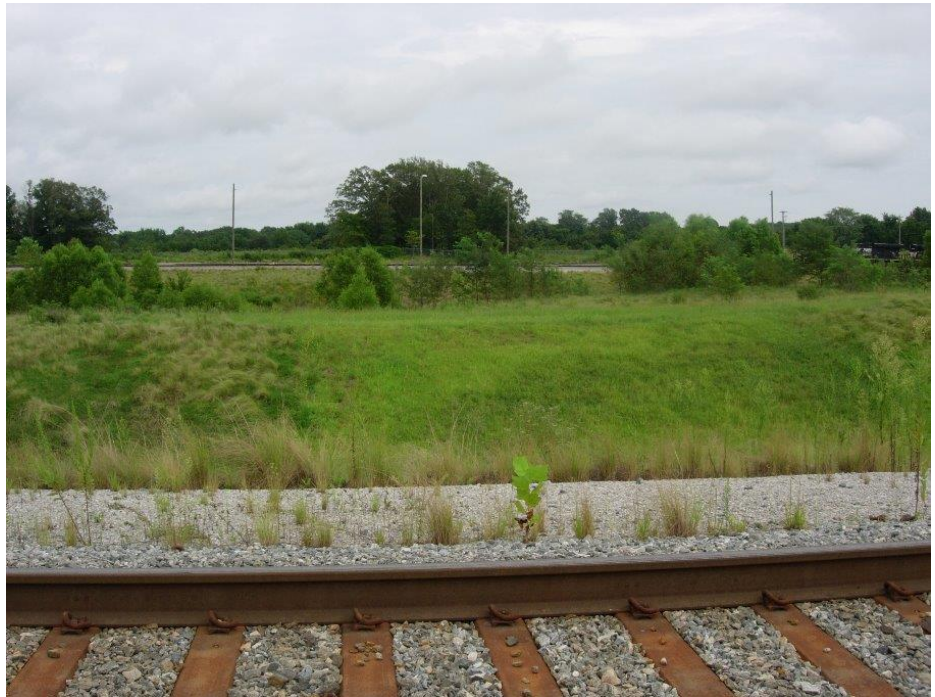
10	Cliff Caudle			
Description				
View east showing a formerly unstable portion of the east slope above the low-flow channel in Permanent Basin 4. The area had been regraded and re-seeded, and was very well-vegetated.

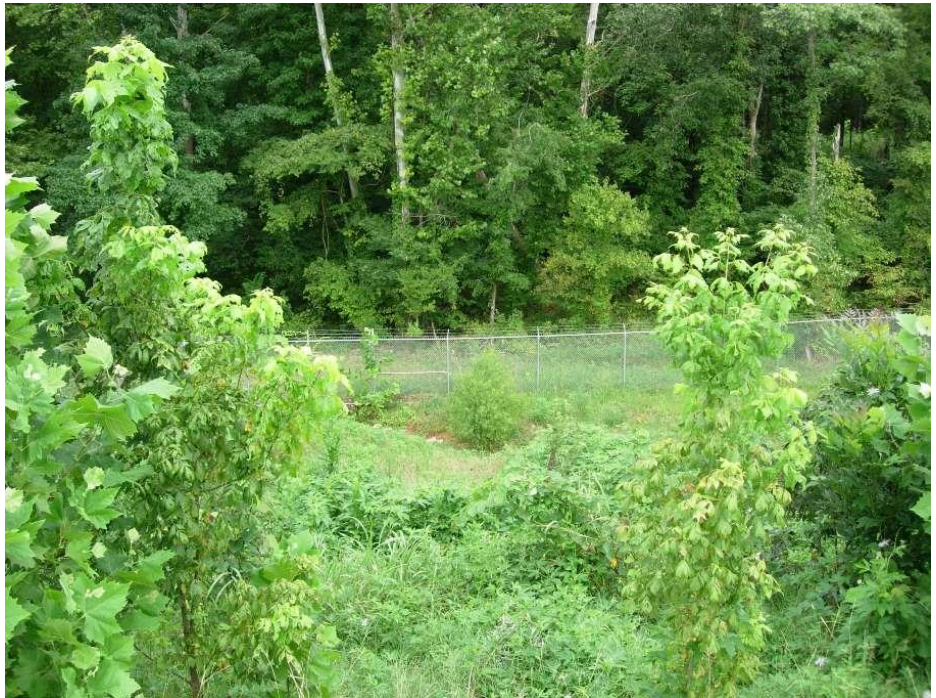
11	Cliff Caudle			
Description				
The area around Outfall SW9 (the discharge point to Stream 5) was mostly well vegetated.

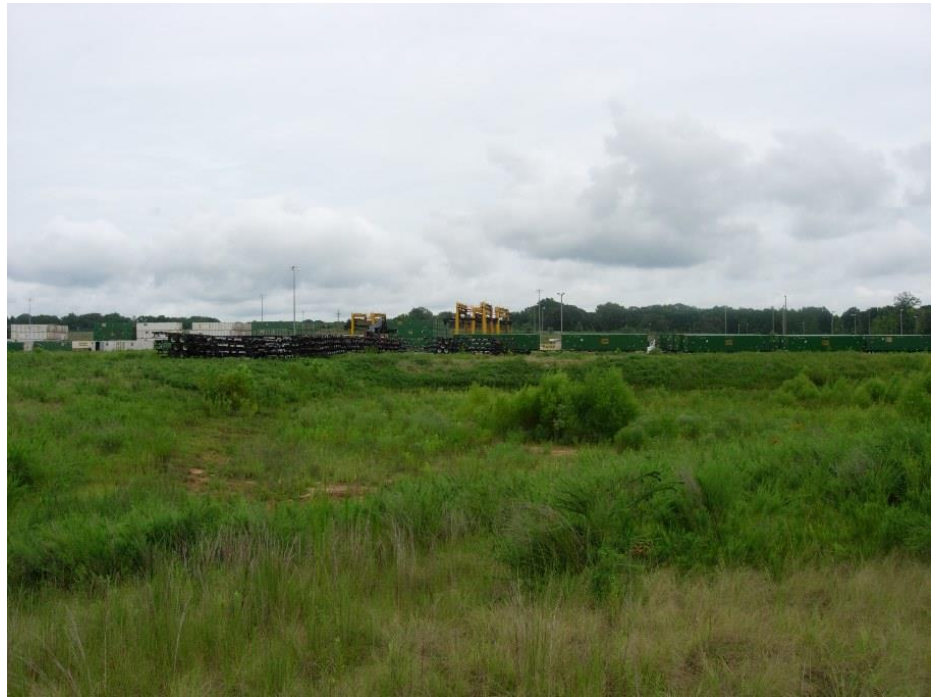
12	Cliff Caudle			
Description				
View east across the north end of Permanent Basin 3, which was mostly well-vegetated.
